NASA Contractor Report 4617

# Results of the Examination of LDEF Polyurethane Thermal Control Coatings

*Johnny L. Golden*  
*Boeing Defense & Space Group • Seattle, Washington*

July 1994

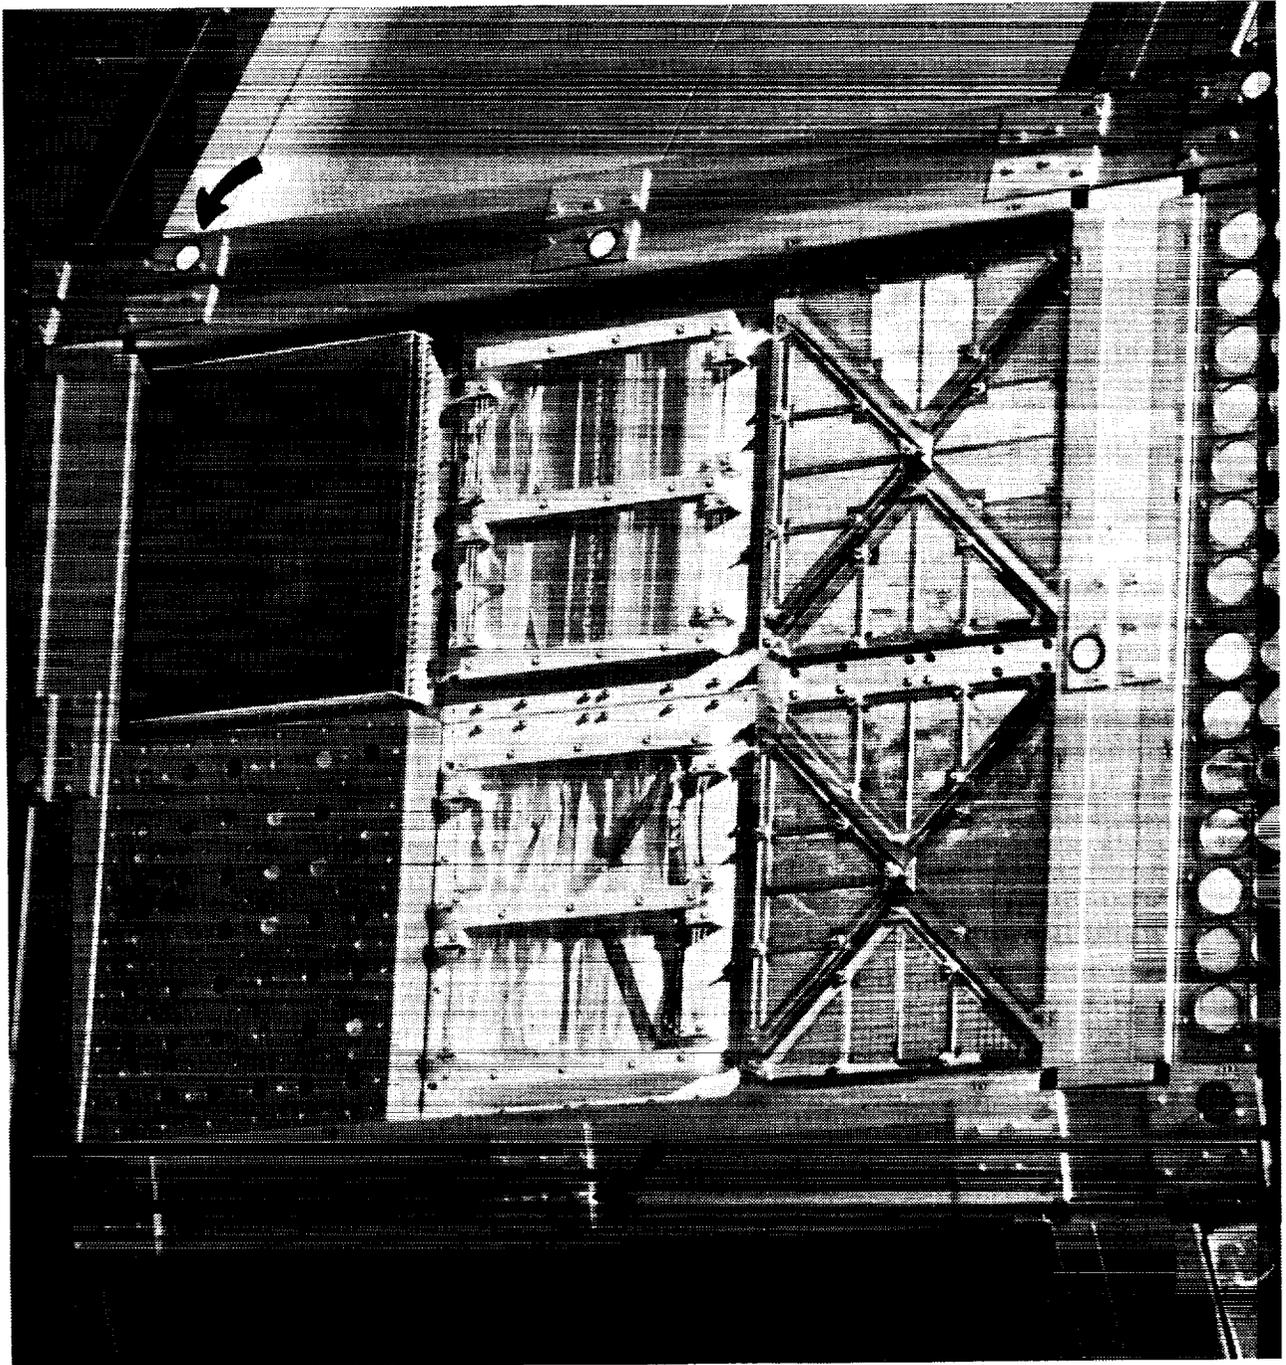
Figure 4. On-orbit view of paint disks on LDEF tray clamps in the atomic oxygen fluence transition region, tray E6. NASA Johnson Space Center Photo No. S32-82-040. Disks on upper longeron (see arrow) were in high AO fluence and are white, disks on lower longeron were in low AO fluence and are brown. See Appendix C for color figure.

Figure C4. On-Orbit view of paint disks on LDEF tray clamps in the atomic oxygen fluence transition area, tray E6. NASA Johnson Space Center Photo No. S32-82-040. Disks on upper longeron were in high AO fluence and are white, disks on lower longeron were in low AO fluence and are brown. Color version of figure 4, page 15.

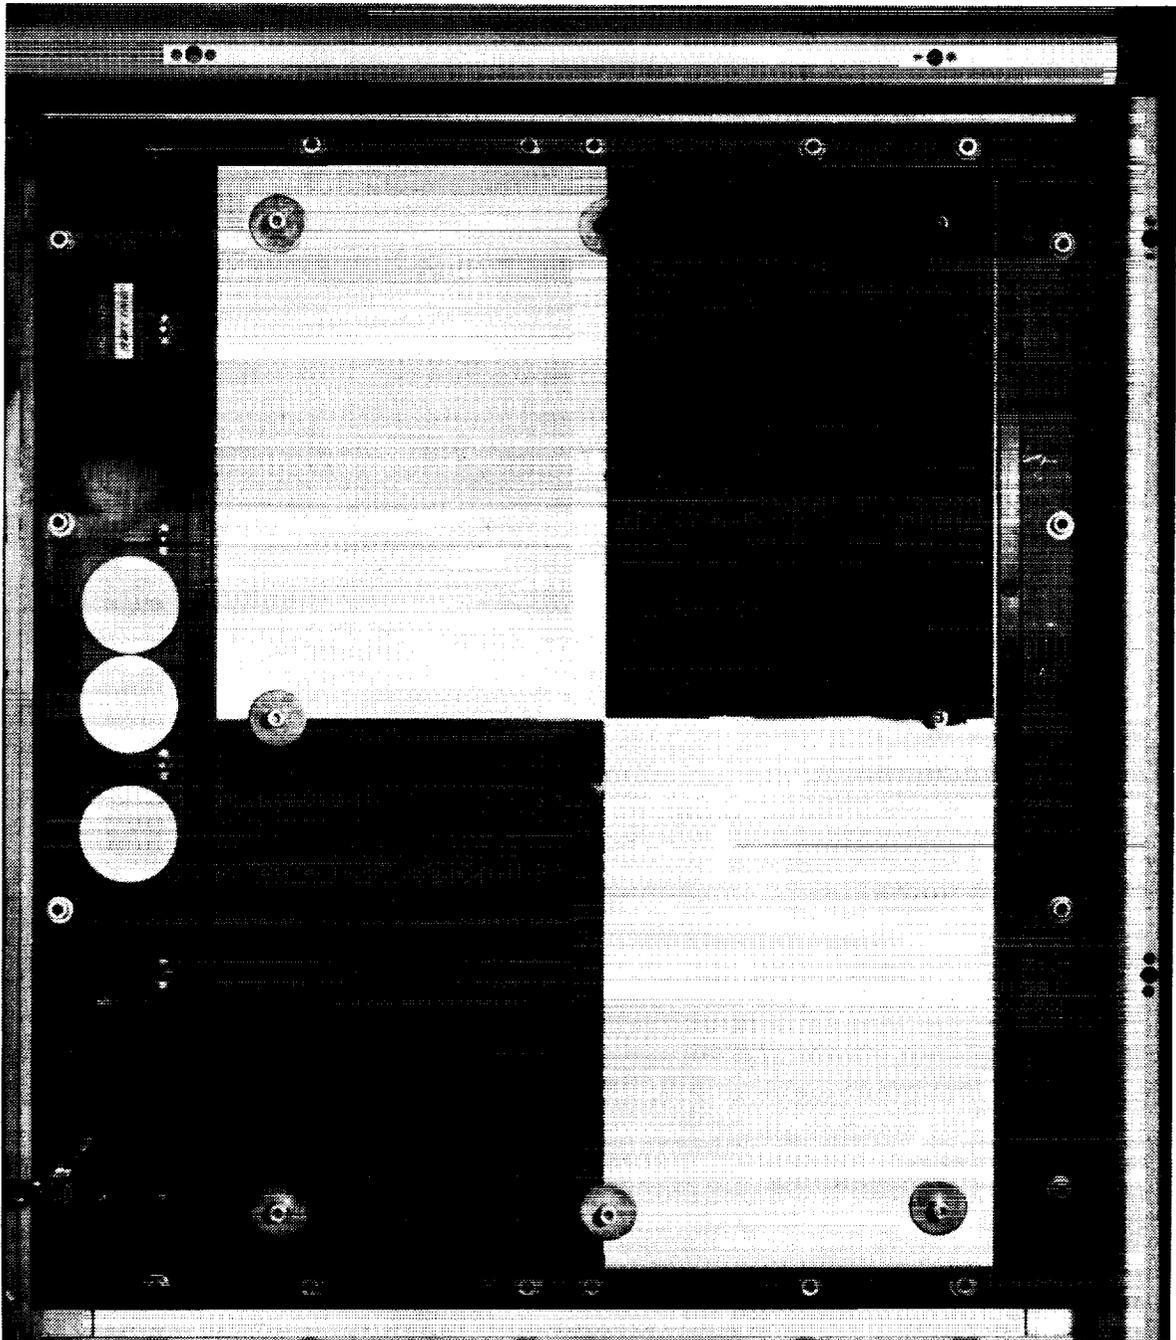
Additional measurements were made in an attempt to clarify the extent of AO attack on the thermal control coatings, where attempts such as cross-sectioning had failed. One such measurement involved the A276 paint on the composite panel from experiment M0003. The composite panel had areas totally protected from atomic oxygen attack, where washers had been used for attachment of the panel to support structure. The measurement involved determining how deeply atomic oxygen was able to penetrate into the layer of remaining pigment particles by measuring how deep the exposed paint was damaged from a physical integrity perspective. Specimens were cut from around the protected attachment areas, and the loose pigment on AO eroded surfaces was totally removed by repeated rag wiping until no more pigment loss was observed. Surface profiles from the specimens were then measured using laser profilometry. Height profiles from these measurements are shown in figures 87 - 92. Figure 87 exhibits an anomalous region at the protected to exposed interface, apparently the result of a cut formed by the sharp edge of the washer when it spun on the surface during fastener removal. Maximum coating loss measurements ranged from 0.00025 inch in figure 92 to 0.00050 inch in figure 90. Average AO erosion damage depth was determined to be 0.00038 inch or 9.6  $\mu\text{m}$ .

Figure 10. LDEF Experiment M0003 - painted composite panel, postflight. The coatings are (clockwise from upper left) Chemglaze A276, Chemglaze Z306, BMS 10-60 White Polyurethane, and unpainted T-300 graphite / 934 epoxy composite.

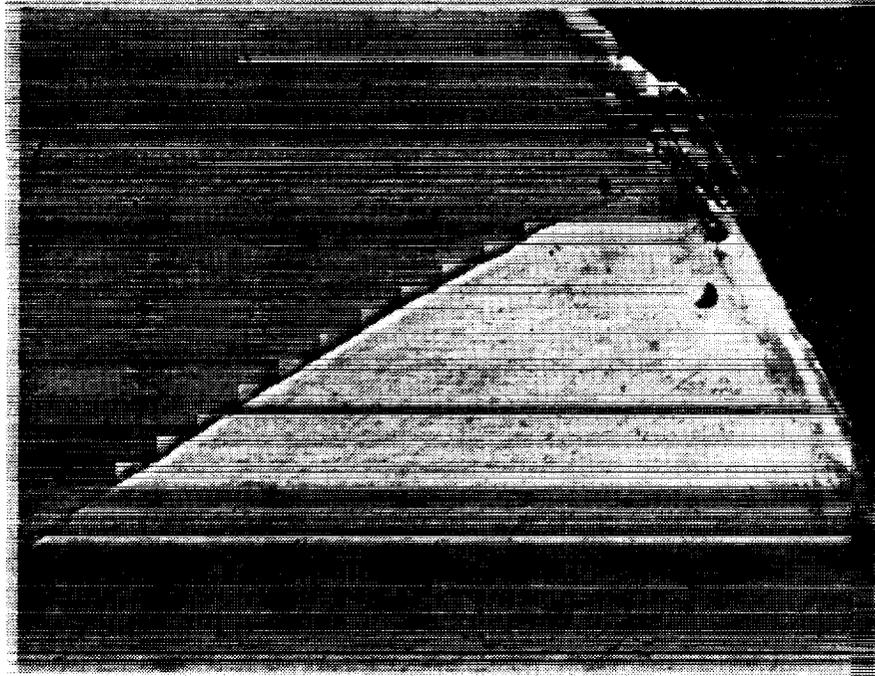
Cracking was observed in the white paint disks located in high AO fluence areas but not in those located in low AO fluence areas. Cracking was sometimes localized to the edge region of these disks (see figures 16 and 17), but was also observed as a pattern of parallel cracks on large areas of the bulk white coating (see figure 18). Occlusions in the

Figure 16. Chemglaze A276 white polyurethane paint on tray clamp B7-2, viewed at 16X magnification. Example of cracking with atomic oxygen erosion.

Figure C16. Chemglaze A276 white polyurethane paint on tray clamp B7-2, viewed at 16X magnification. Example of cracking with atomic oxygen erosion. Color version of figure 16, page 25.

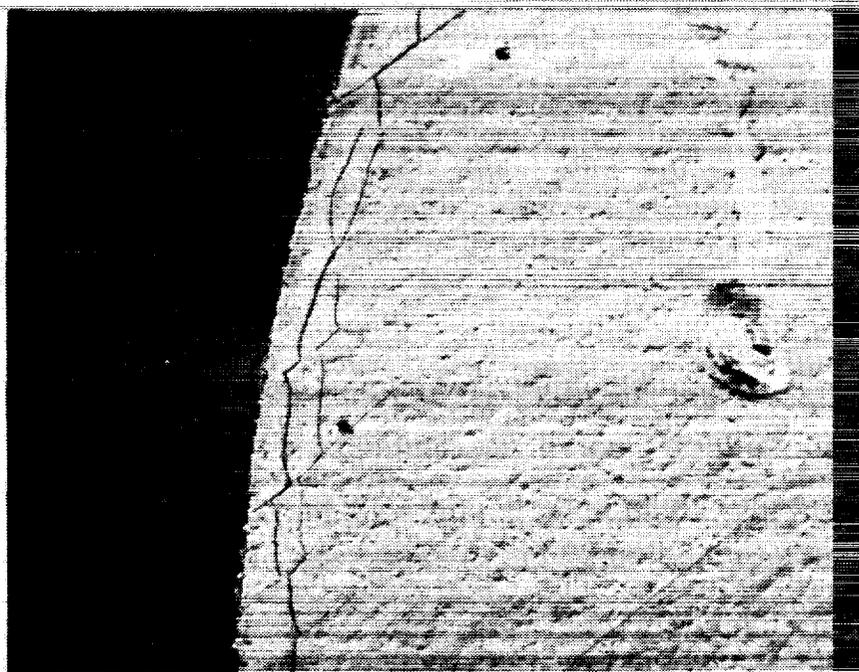
Figure 17. Chemglaze A276 white polyurethane paint on tray clamp C8-5, viewed at 16X magnification. Edge cracking and fragility of the surface are shown. See Appendix C for color figure.

Figure C17. Chemglaze A276 white polyurethane paint on tray clamp C8-5, viewed at 16X magnification. Edge cracking and fragility of the surface are shown. Color version of figure 17, page 25.

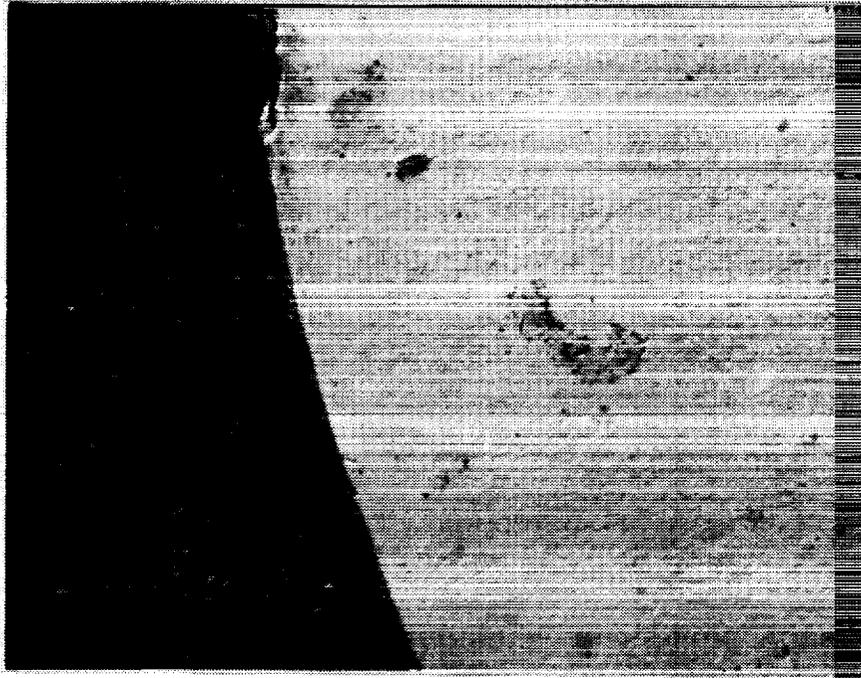
white paint were also made visible through the process of AO erosion (see figures 19 and 20). AO erosion left a very fragile surface layer on the white A276 paint that was occasionally damaged by incidental handling during deintegration and storage (see figures 17, 21, and 22). AO erosion of the black Z306 paint is also apparent, based on visibility of the red primer layer (see figure 23).

Figure 19. Chemglaze A276 white polyurethane paint on tray clamp B7-2, viewed at 16X magnification. Occlusions in paint were exposed with AO erosion.

Figure C19. Chemglaze A276 white polyurethane paint on tray clamp B7-2, viewed at 16X magnification. Occlusions in paint were exposed with AO erosion. Color version of figure 19, page 27.

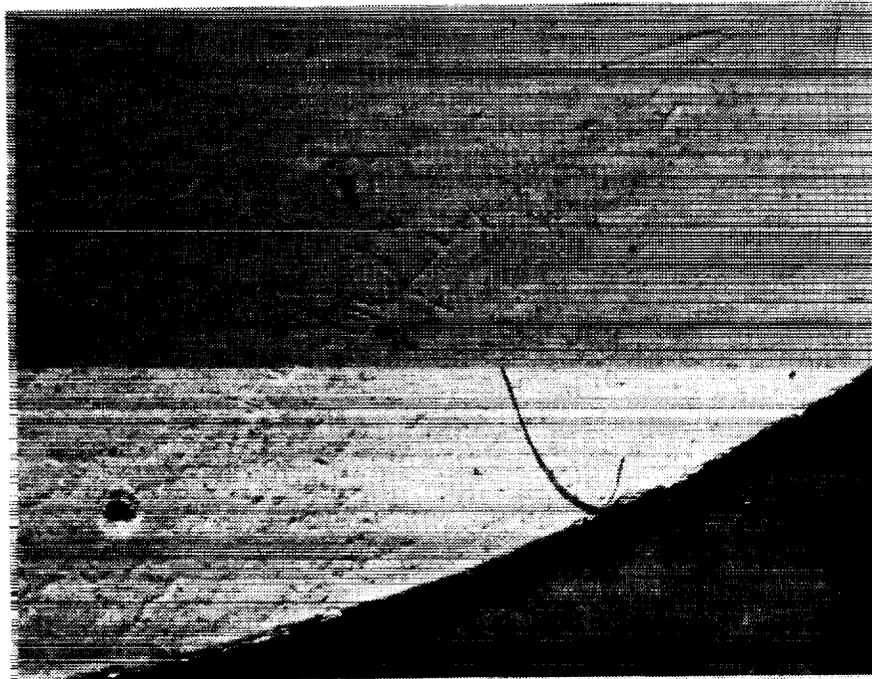
Figure 22. Chemglaze A276 white polyurethane paint on tray clamp C8-5, viewed at 16X magnification, showing a small debris impact and handling damage. See Appendix C for color figure.

Figure C22. Chemglaze A276 white polyurethane paint on tray clamp C8-5, viewed at 16X magnification, showing a small debris impact and handling damage. Color version of figure 22, page 28.

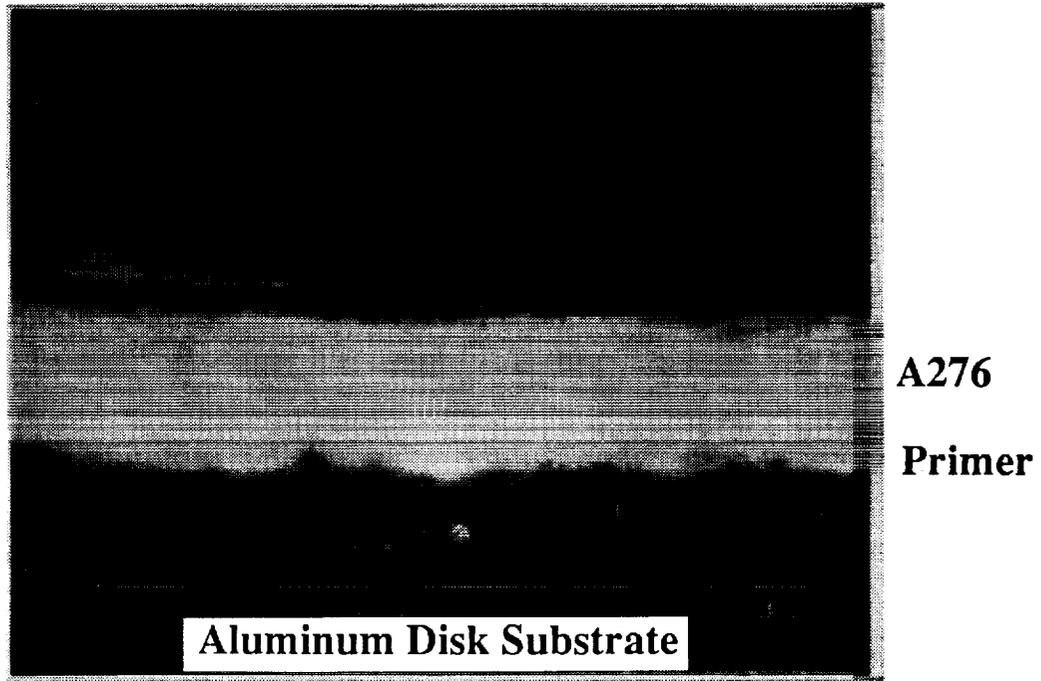
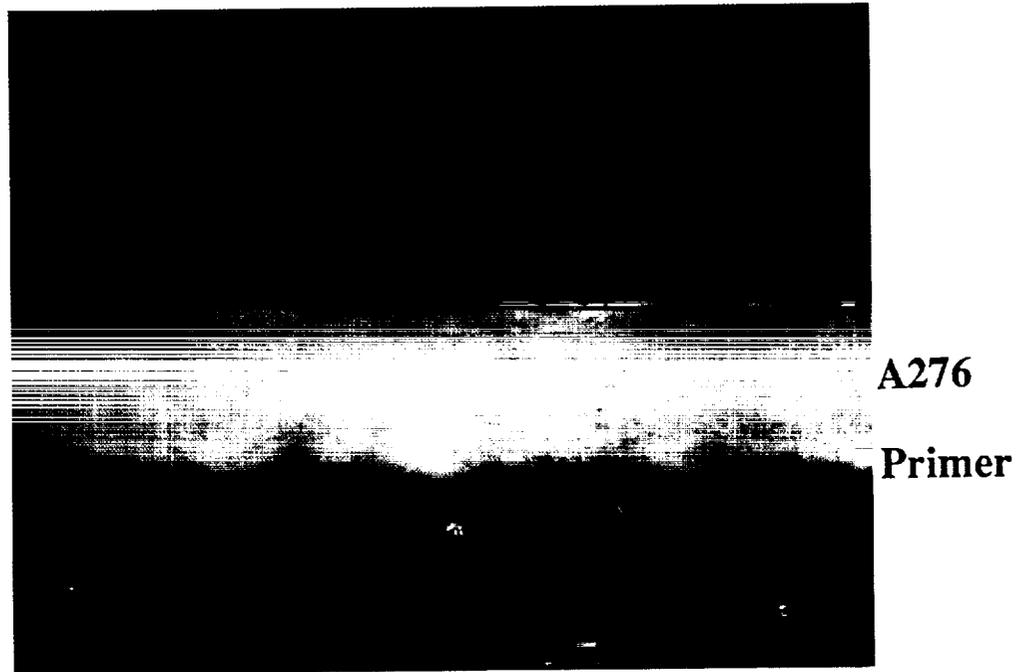
Cross-sections were made of four disk specimens from different environments on the LDEF surface, after all nondestructive measurements for those specimens had been completed. Cross-sectioning done in an attempt to measure the depth of atomic oxygen induced resin recession on the leading edge white paint specimen was not successful. The surface of the eroded white paint specimens is essentially pigment particles, held in place by weak attractive forces due to the small size of the particles. When trying to mount the cross sections prior to polishing, those loosely attached pigment particles 'washed' off of the surface as seen in figure 46, making resin erosion measurements impossible.

Figure 46. Cross-section of Chemglaze A276 white paint on tray clamp C8-5 (500X magnification), showing lifting of loose pigment into the encapsulant.

Figure C46. Cross-section of Chemglaze A276 white paint on tray clamp C8-5 (500X magnification), showing lifting of loose pigment into the encapsulant. Color version of figure 46, page 47.

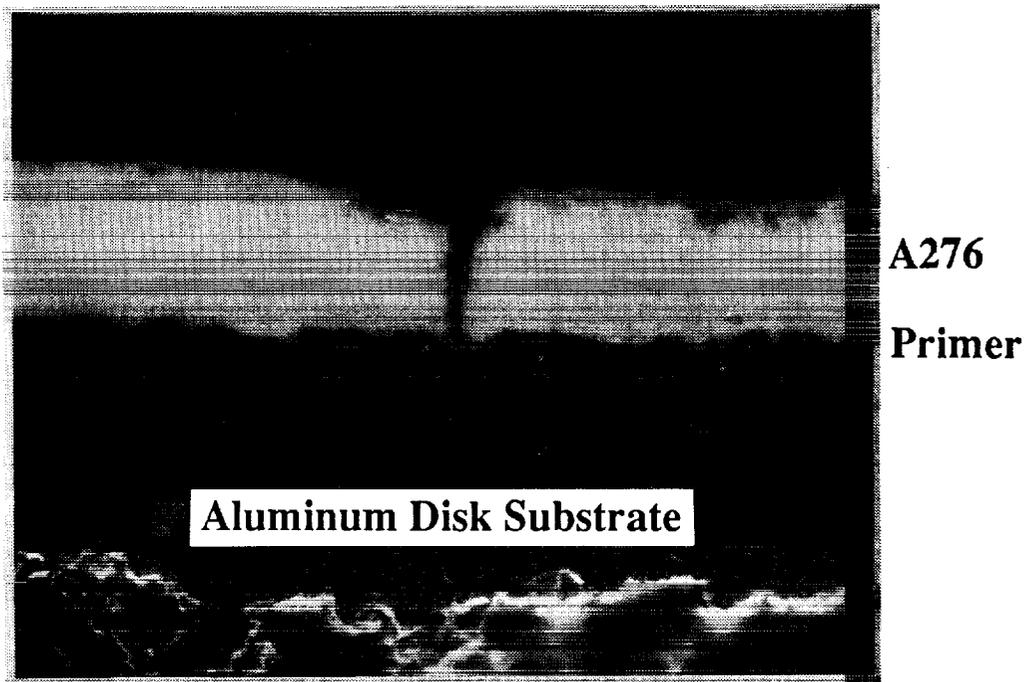
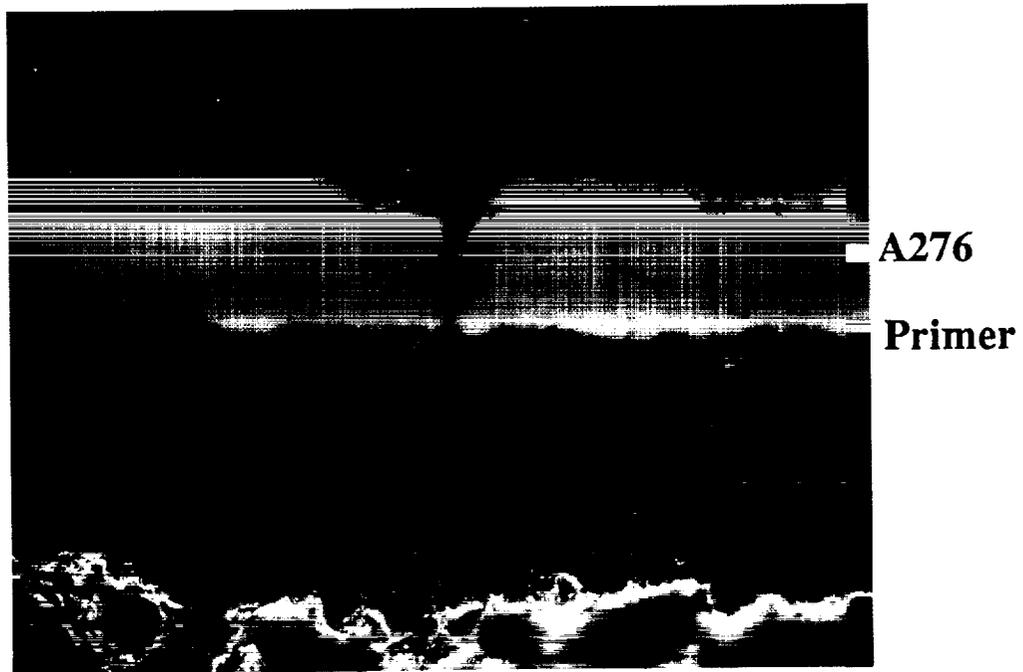
Cracks observed by optical microscopy in the surfaces of leading edge white paint specimens (see figure 18) were observed in cross-section, as shown in figure 47. All cracks observed went completely through the coating system to substrate.

Figure 47. Cross-section of Chemglaze A276 white paint on tray clamp C8-5 (500X magnification), showing a typical crack passing down to aluminum substrate. See Appendix C for color figure.

Figure C47. Cross-section of Chemglaze A276 white paint on tray clamp C8-5 (500X magnification), showing a typical crack passing down to aluminum substrate. Color version of figure 47, page 47.

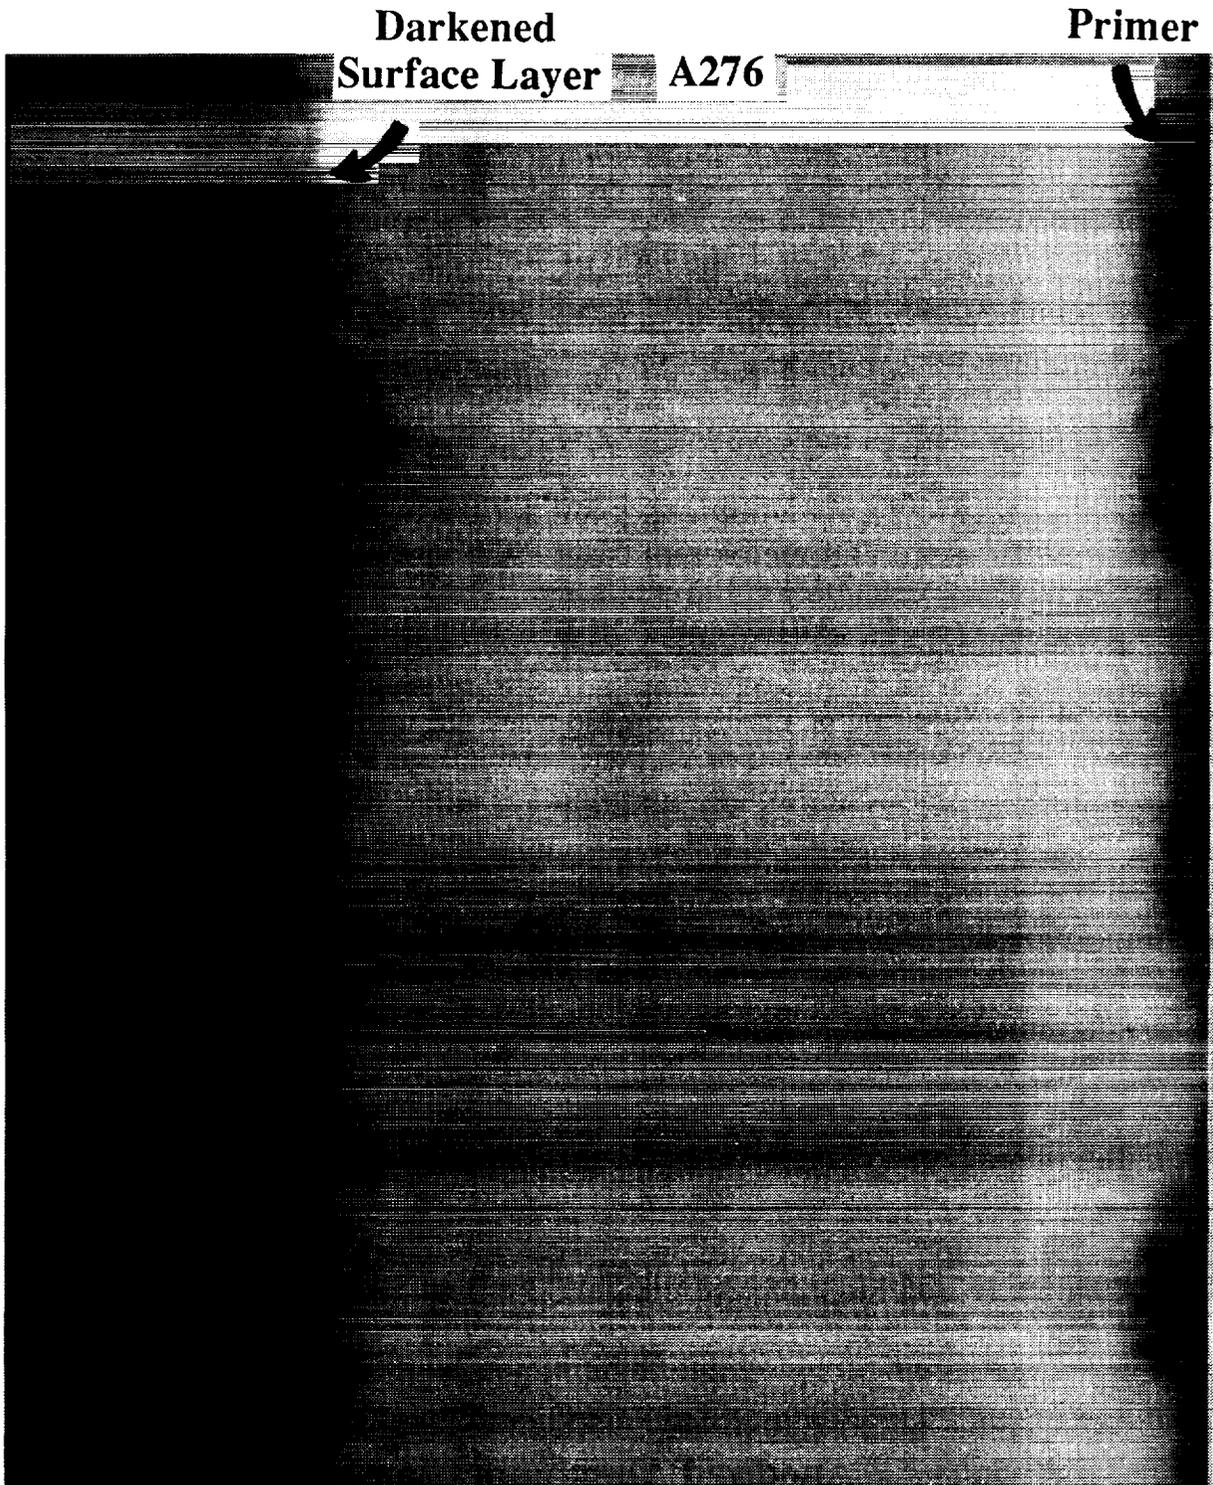
Cross-sectioning was also used to characterize the darkened surface of trailing edge white paint on specimen B4-7. As pictured in figure 56, the darkened, or discolored layer in the white paint was found to be extremely thin, comparable to the size of the titania pigment particles or approximately 0.2  $\mu\text{m}$  in thickness. There also appeared to be titania pigment particles located in the discolored portion, indicating that the discoloration was due to radiation darkening of the very surface layer of the paint resin.

Figure 56. Cross-section of Chemglaze A276 white polyurethane paint on tray clamp B4-7 at 2500X magnification. Titania particles are visible to the very surface of the paint. The discolored layer is very thin,  $\sim 0.2 \mu\text{m}$ . See Appendix C for color figure.

Figure C56. Cross-section of Chemglaze A276 white polyurethane paint on tray clamp B4-7 at 2500X magnification. Titania particles are visible to the very surface of the paint. The discolored layer is very thin,  $\sim 0.2 \mu\text{m}$ . Color version of figure 56, page 52.
